Determining Root Causes of Mysterious Hardware Failures using High Resolution CT Scanning

Michael R. Johnson

Jet Propulsion Laboratory

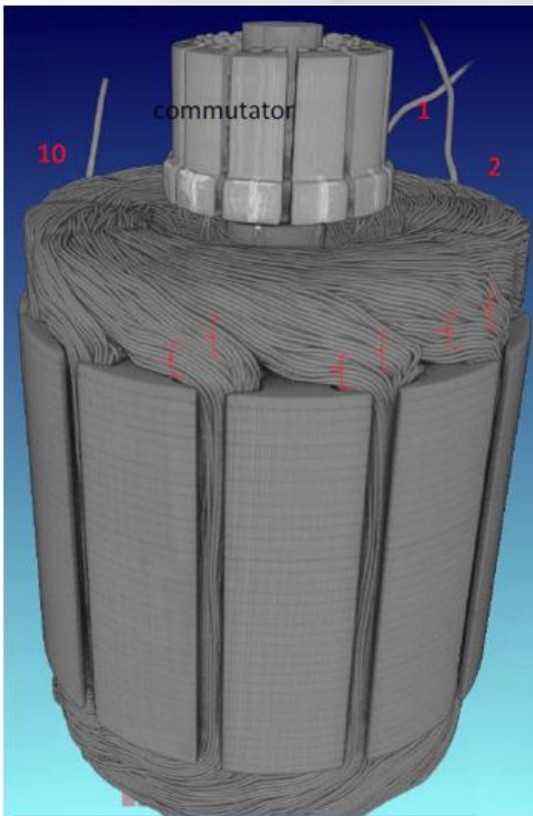
- CT X-ray inspection revealed a great many things!

Rotor Assembly

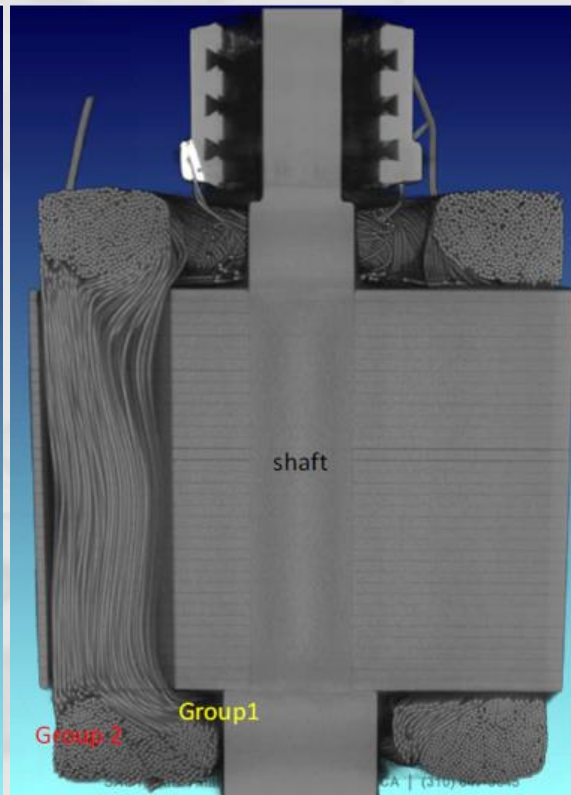
*Section of Rotor Showing
Wires in the Slot*

- The CT scanned model provides the opportunity to investigate the individual wires within the winding assembly
- The model allowed zooming into the areas where the cracks in the epoxy were identified in the optical inspection
- Wire damage seemed to be apparent at the locations of the cracks in the epoxy

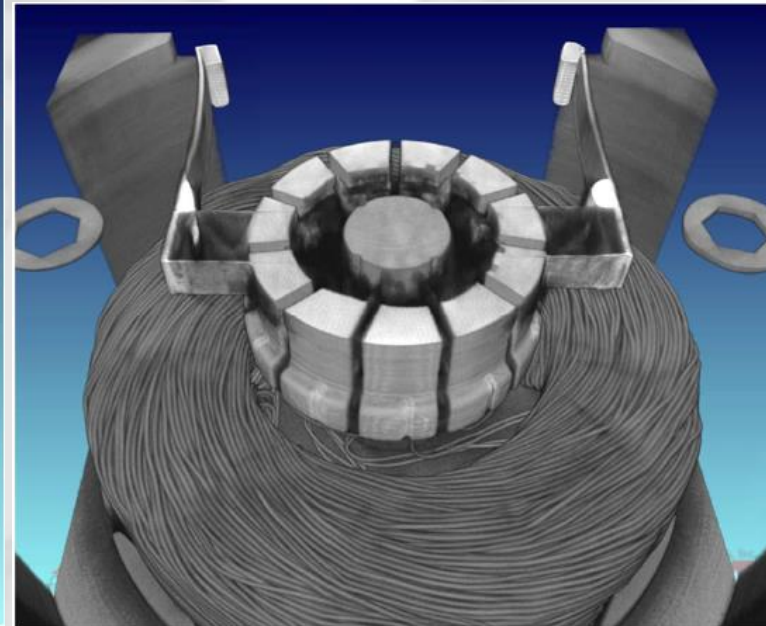
*Brushes, Commutator,
and Cantilever Arms*

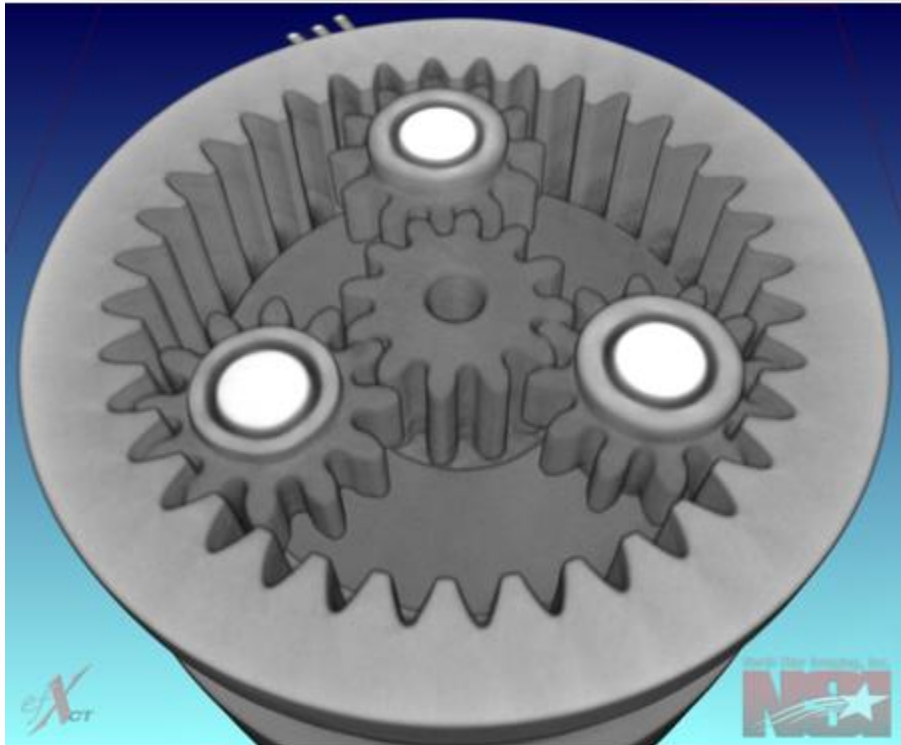
- The gearbox was considered the most likely source of the failure so it was inspected in detail first

Output Planetary Gear Stage

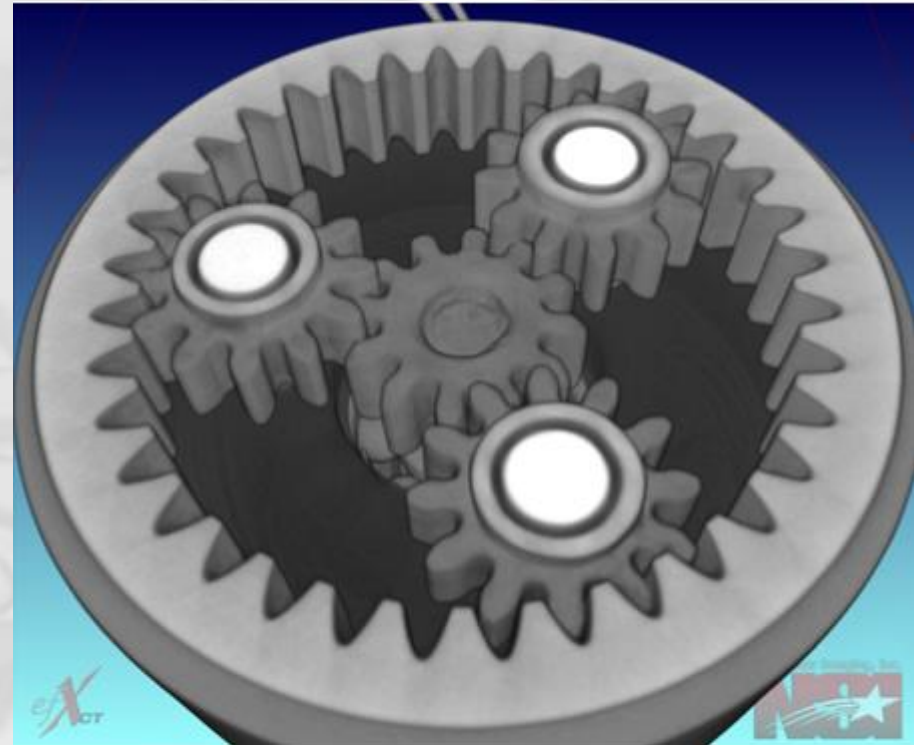
*Input Planetary Gear Stage with the Motor
Pinion at the Center*

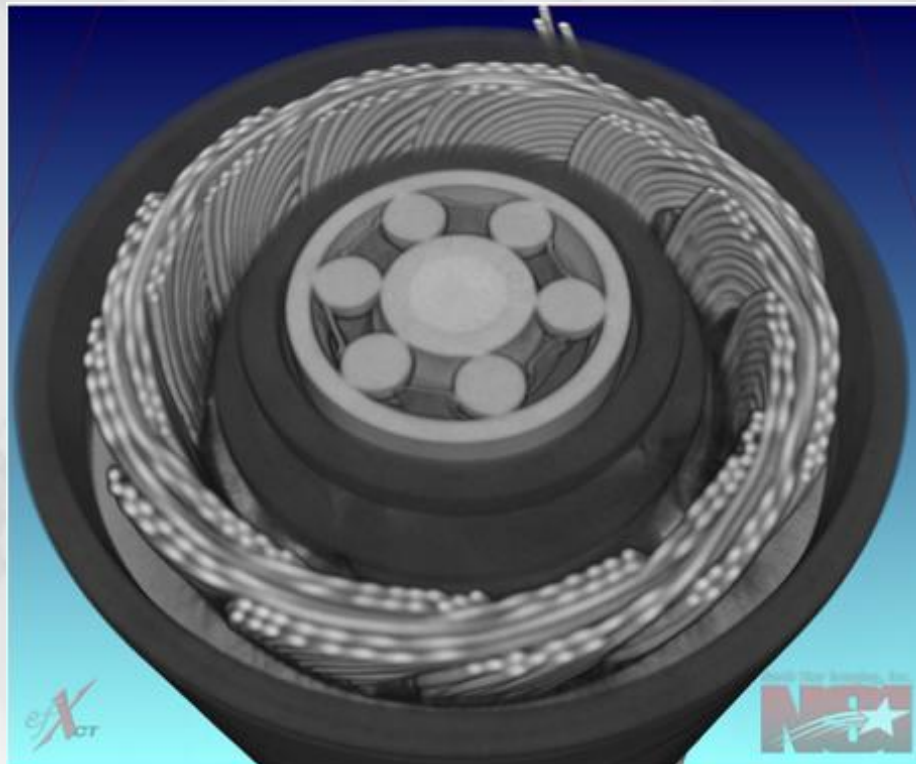
- Moving down through the actuator to the output of the motor revealed no failure sources . . .

*Front Motor Bearing Closest to the Gearbox
Input*
